May 10, 2016

2486

Geotechnical Evaluation
SH-14, Slide Repair near Elk City
Idaho County, Idaho
Project No. A019(782), Key No. 19782

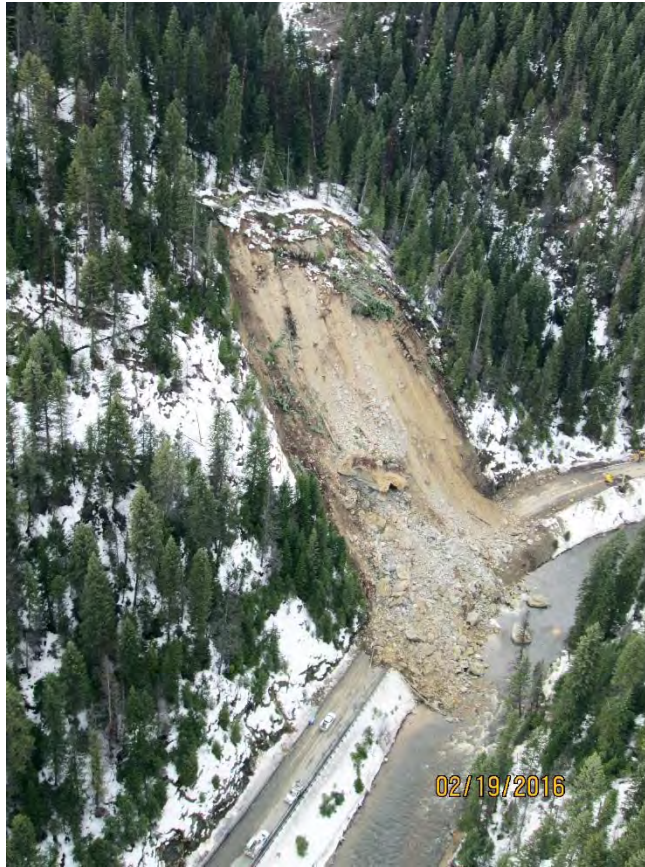
A. Aerial view of the landslide looking north (taken on February 19, 2016).

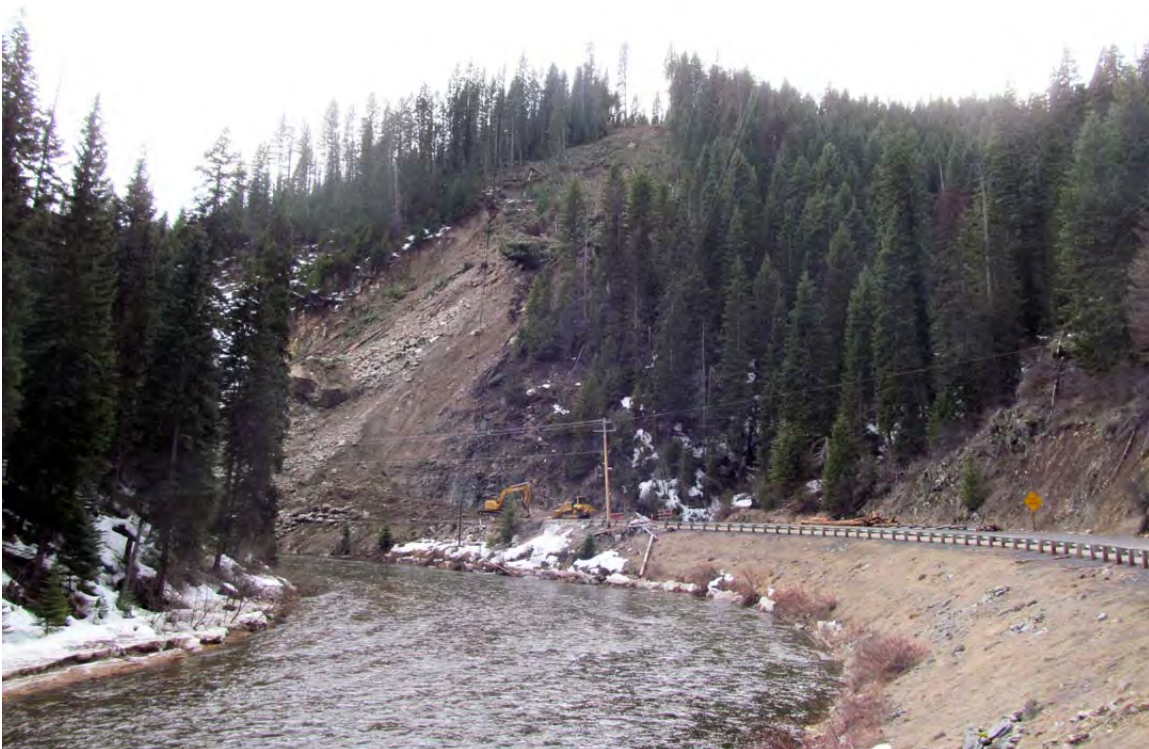
B. View of the landslide looking southwest (taken on March 12, 2016).

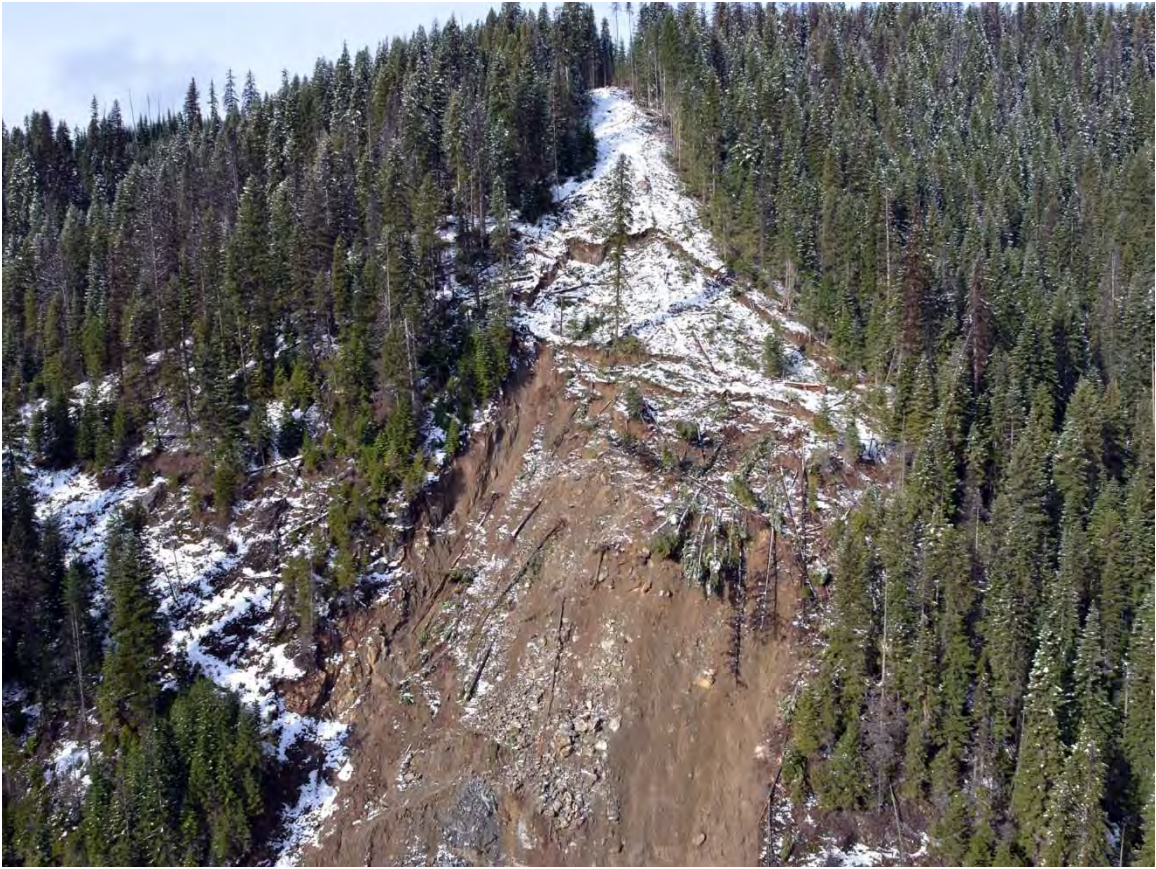
A. Aerial view of the upper half of the landslide looking west (March 27, 2016).

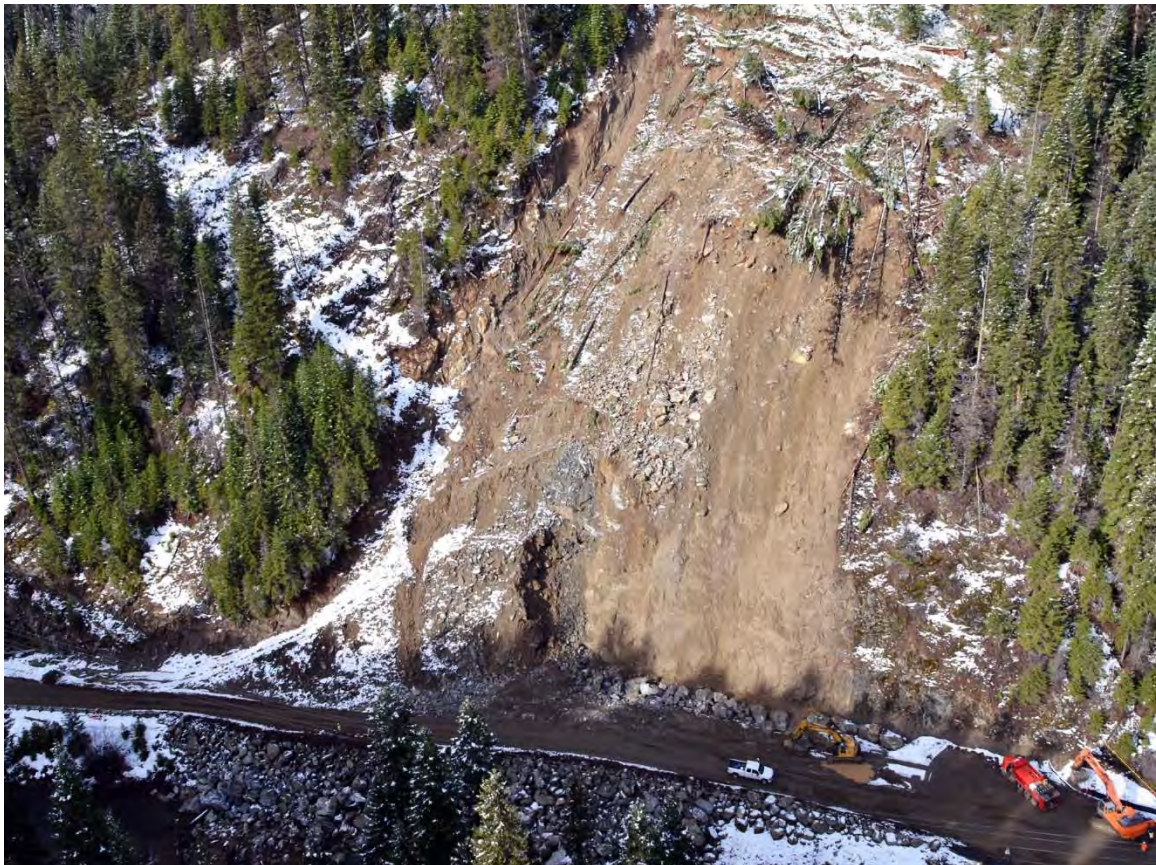
B. Aerial view of the lower half of the landslide looking west (March 27, 2016.)

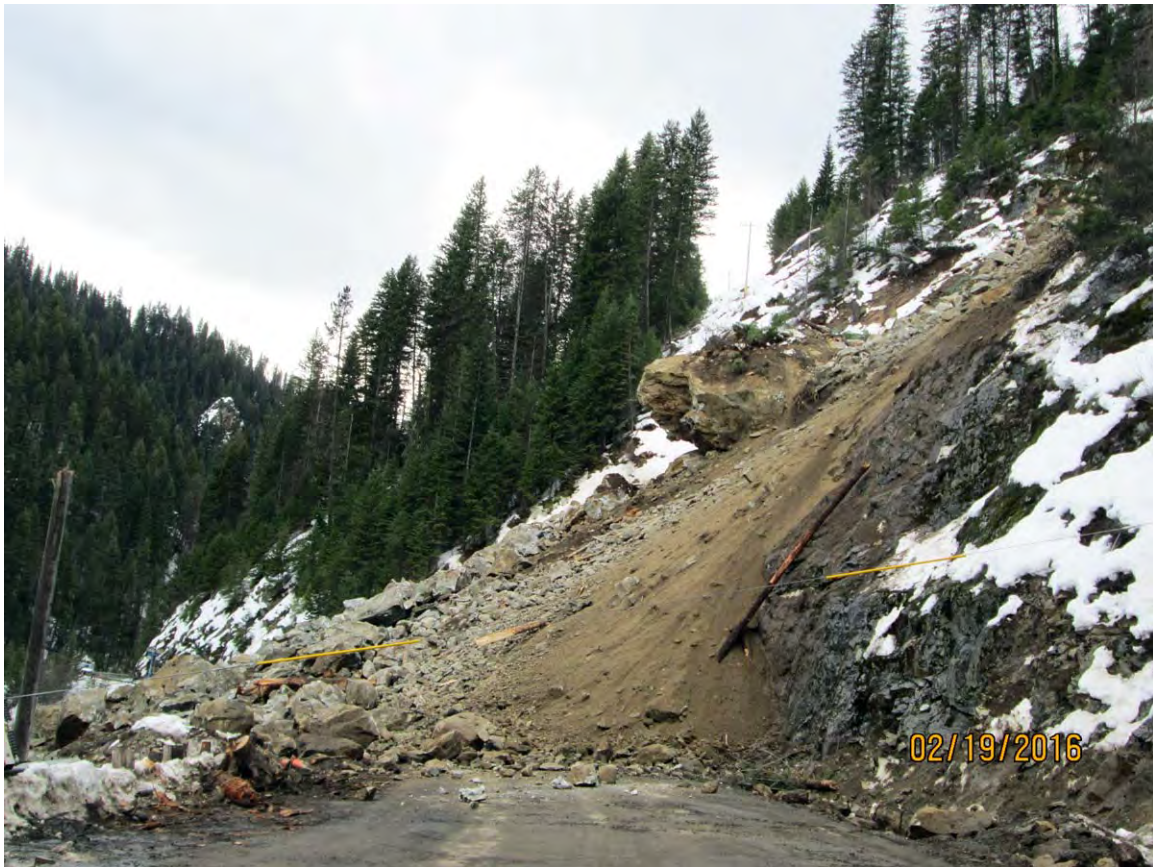
A. View looking south at slide debris that buried SH-14 following the landslide event on February 18, 2016. Note the large rock block within the debris.

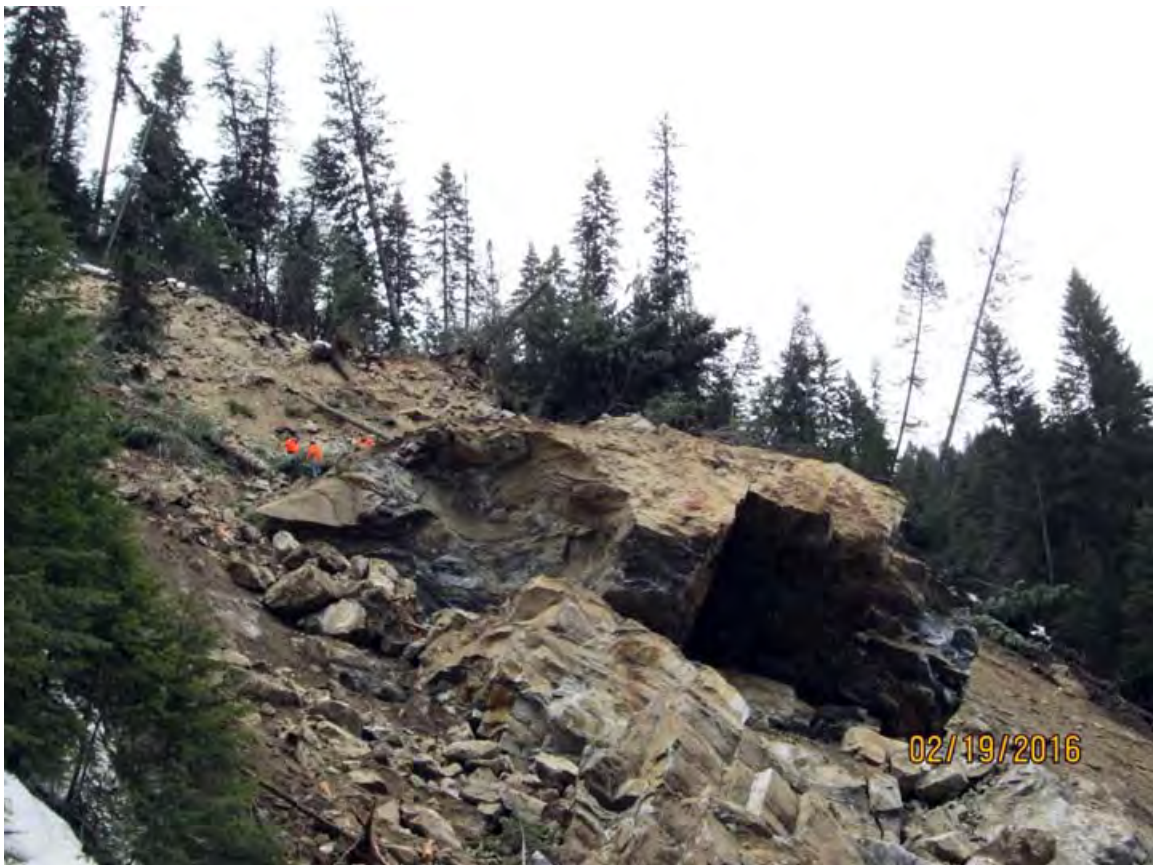
B. View looking northwest at the large rock block within the slide debris. The rock block is approximately 30'x70'x50' in size.

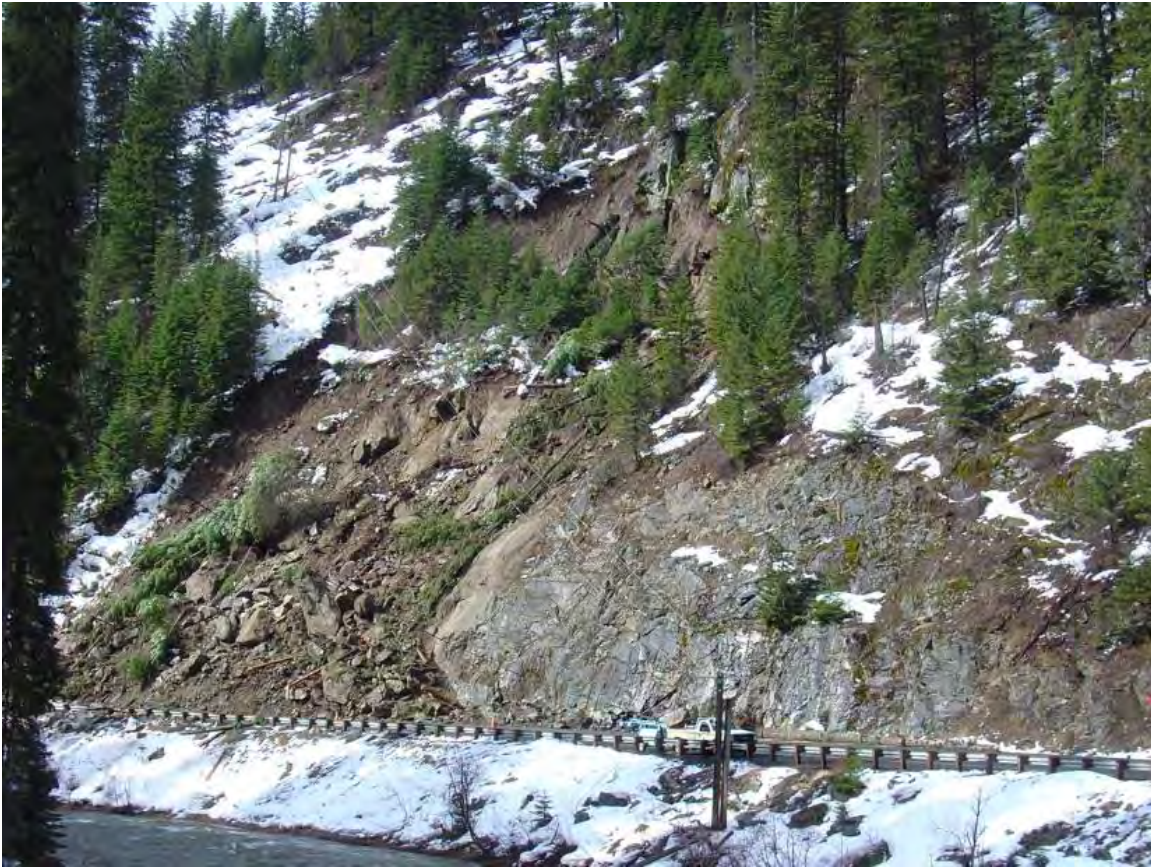
A. View looking southwest of the 2011 failure event.

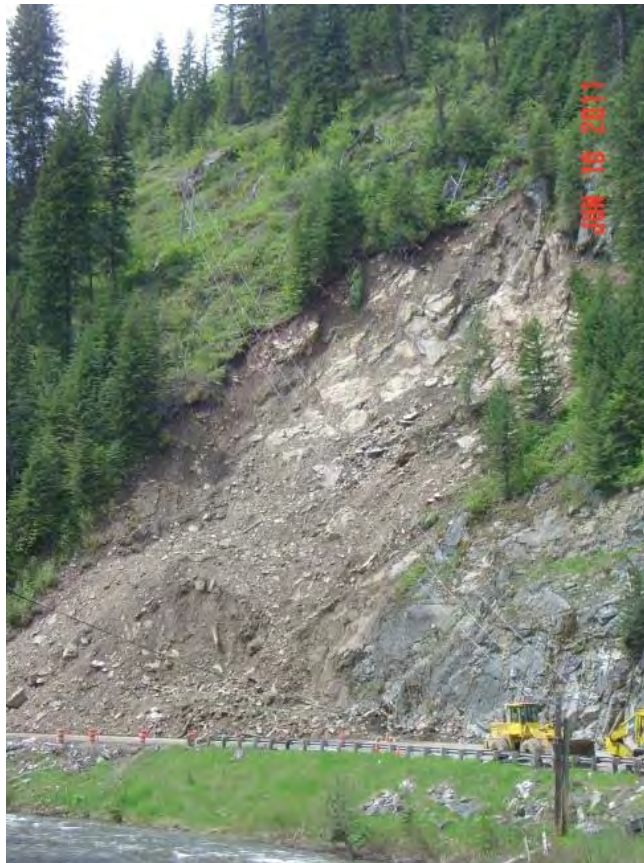
B. View looking southwest of slide debris and rockfall removal efforts in June 2011.

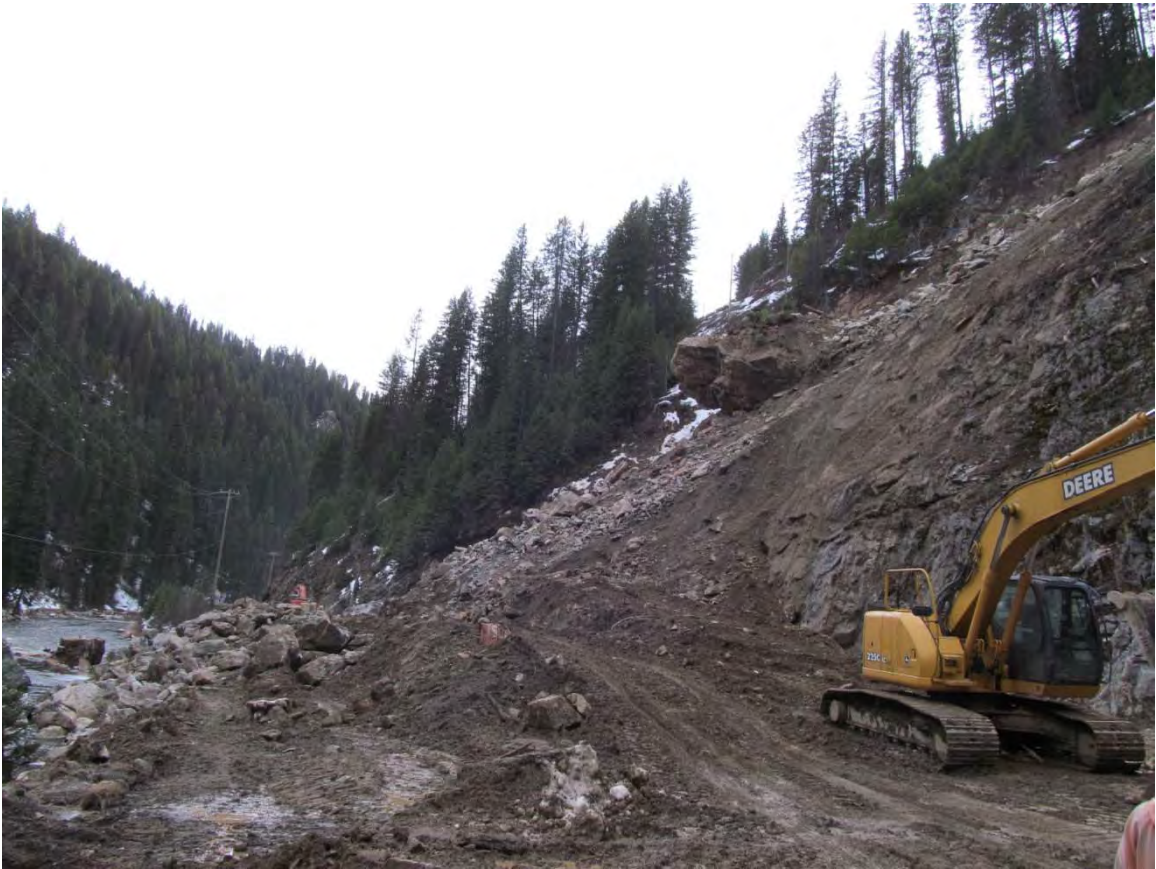
A. View looking south of slide debris being removed and a shoofly road being constructed on March 12, 2016.

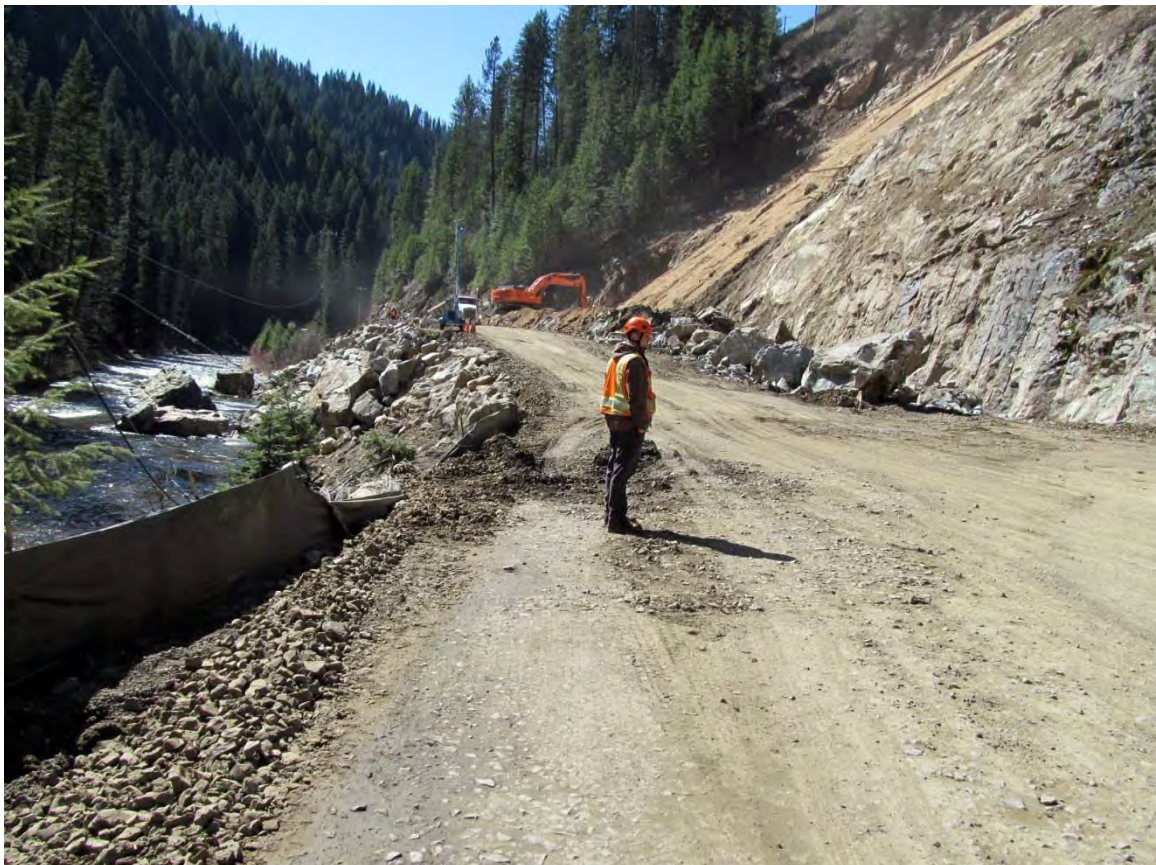
B. View looking south of completed shoofly road along toe of slide on April 6, 2016.

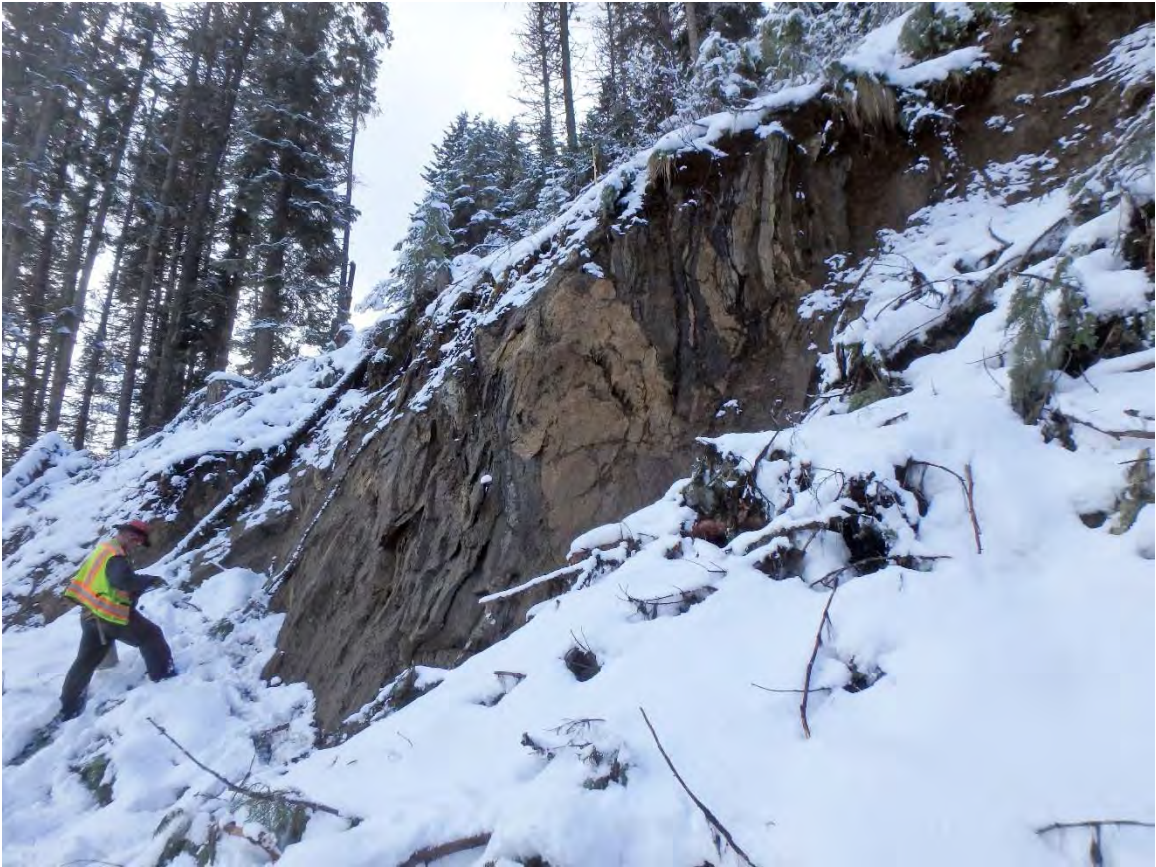
Features observed suggested the slide was not surficial in nature. It appears that the slide movement is complex, occurring both in soil and at the contact with (or within) bedrock. No in-place bedrock was observed within the base of the headscarp or on the slide mass. Highly saturated and soft ground conditions were observed within the slide debris as well as above the slide mass. The two major landslide events (2011 and 2016) occurred during the wetter parts of the year in the winter and spring; indicating elevated groundwater conditions likely played a major factor in the landslide movement. There also appears to be two directions of slide movement, which is likely controlled by regional geologic structures.

A. View looking southwest at the active headscarp of the slide (March 13, 2016).

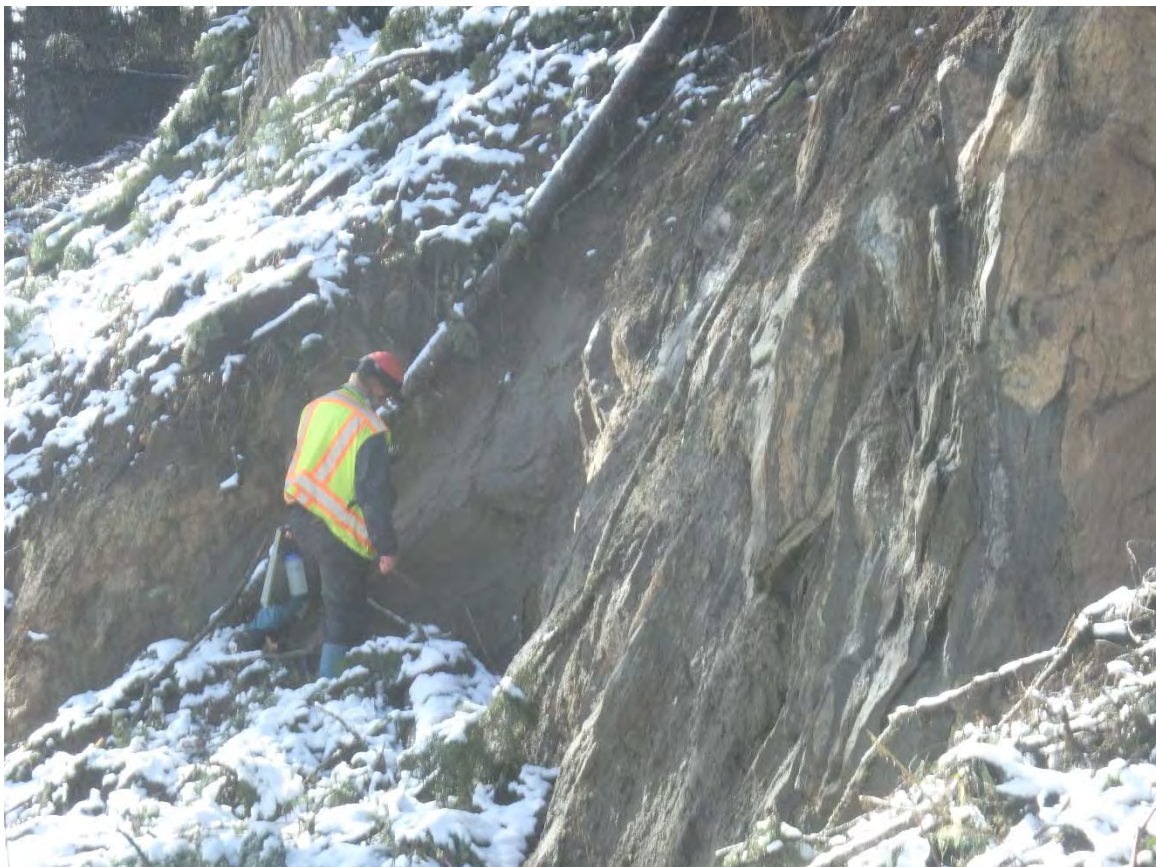
B. Close-up view of the headscarp (March 13, 2016).

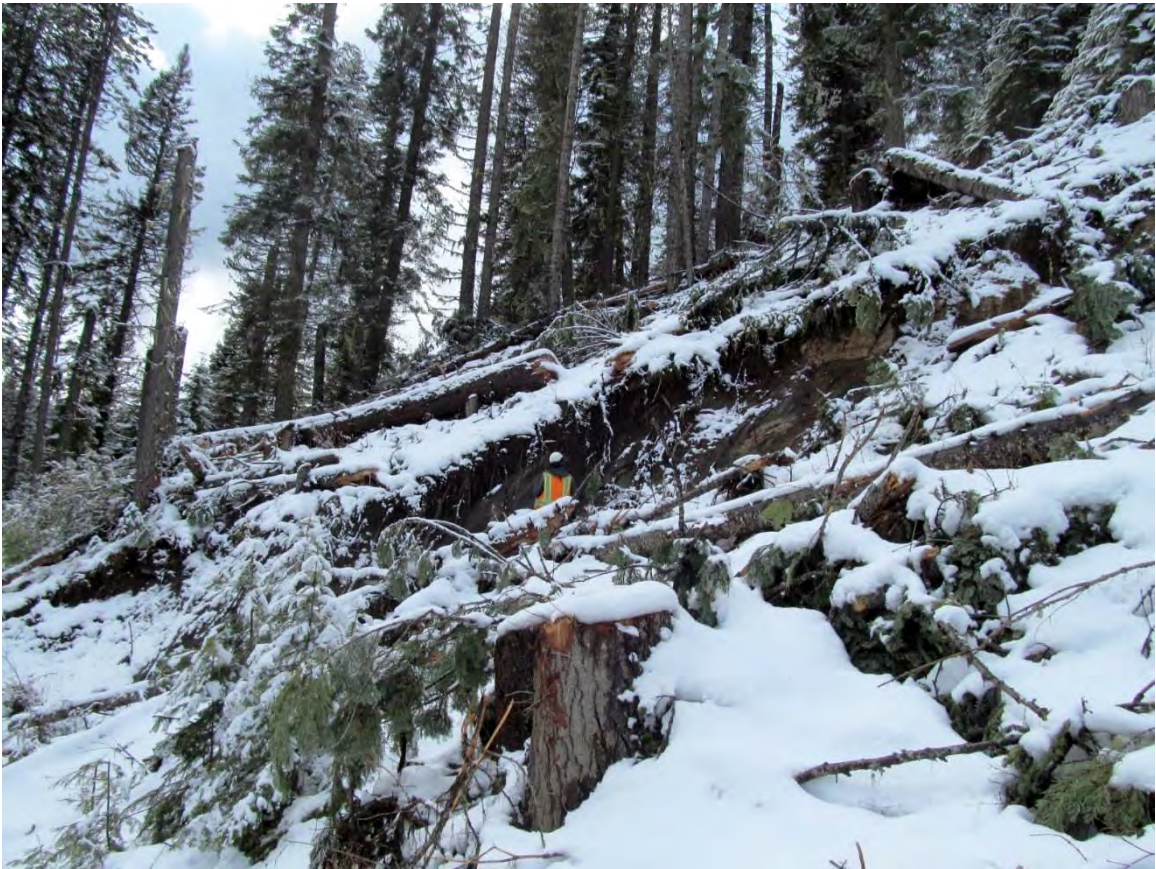
A. View looking south at southern extent of the lateral slide limit near the active headscarp (March 13, 2016).

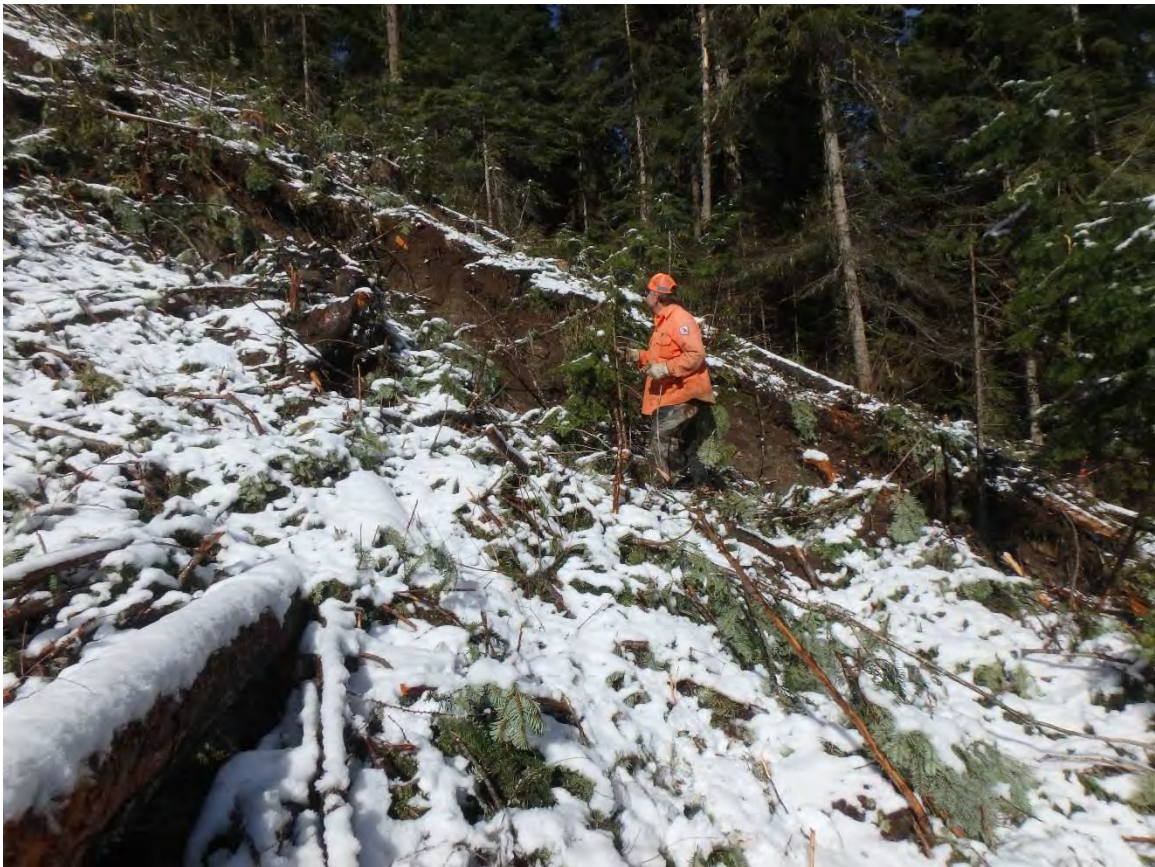
B. View of the northern extent of the headscarp looking north (March 13, 2016).
